GALTEE MOUNTAINS PATH STUDY

Final Report

Author:	Chris York
Version:	1.2
Date of Release:	7 March 2016
Contact:	chris.york@walking-the-talk.co.uk
Web:	www.walking-the-talk.co.uk

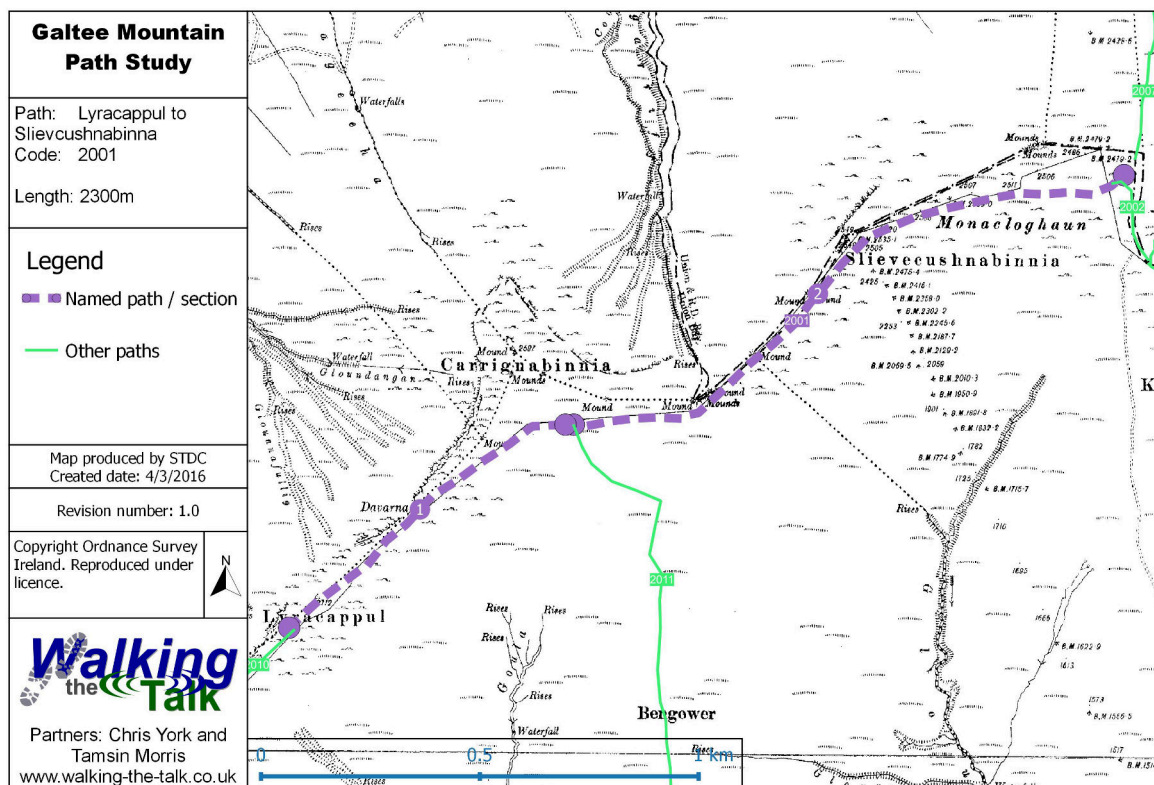
4.1 LYRACAPPUL TO SLIEVECUSHNABINNA

There are a number of parallel braids and the route is obvious on the ground (in clear conditions). Localised damage occurs where there is poor surface drainage and trampling has impacted on the vegetation, with some small areas of bare peat.

The largest area of bare peat appears to have been caused by quad bikes / scramblers driving repeatedly over a flat wet area. This is having knock-on effects for the walkers' route as this has increased the surface run-off, making the route much wetter where it crosses the outflow from the eroded area.

Continued use of this area by quad bikes / scramblers is likely to have an increasingly large impact on the vegetation and underlying peat and may lead to complete erosion of peat down to the underlying mineral soil in places.

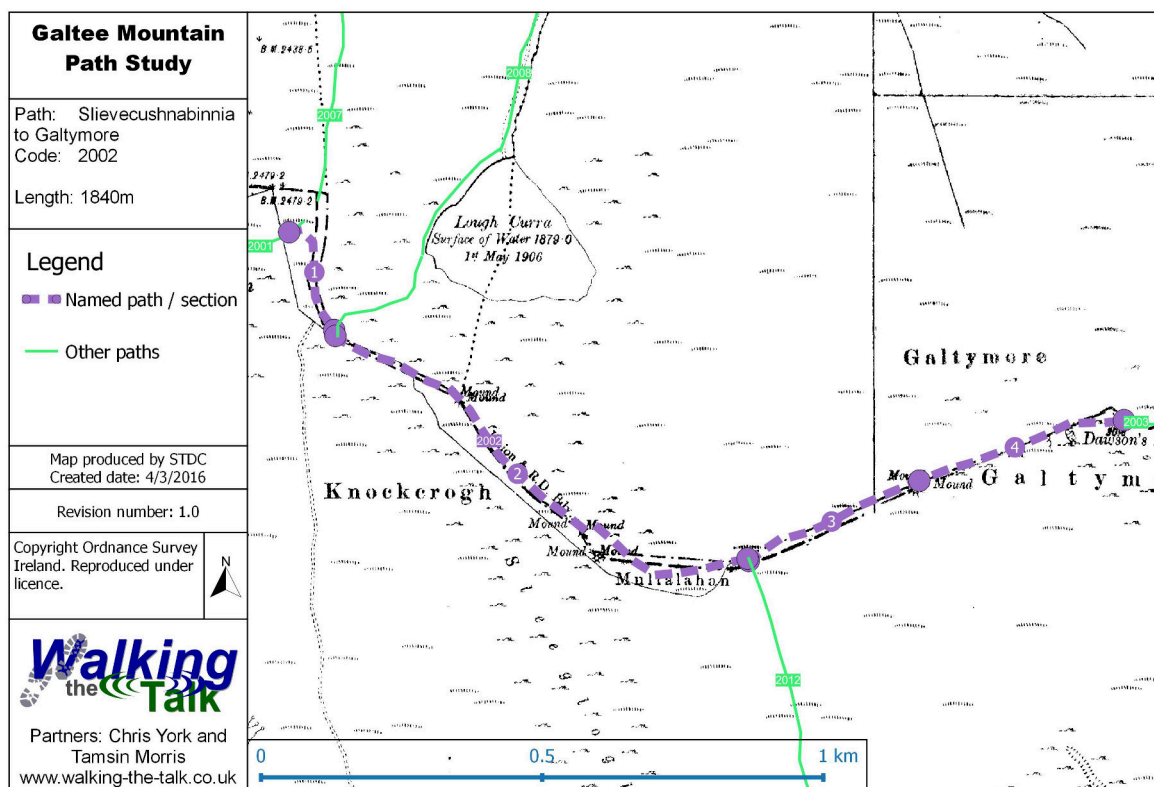
4.2 SLIEVECUSHNABINNIA TO GALTYSORE

There are multiple braids and wide trample zones in places indicating higher levels of use than the western end of the ridge. On steeper slopes there are well developed desire lines exposing the mineral soil, some of which are beginning to show signs of deterioration. On flatter ground poor drainage is causing walkers to disperse, widening the area of damage. Some areas of deep peat have exposed edges caused in part by trampling, leading to loss of peat and fragmentation of the blanket bog habitat.

The levels of use appear to be causing degradation and the exposed mineral soil is at risk of erosion, particularly where the desire lines follow the 'fall line' (directly uphill) allowing the development of small gullies. Exposed peat

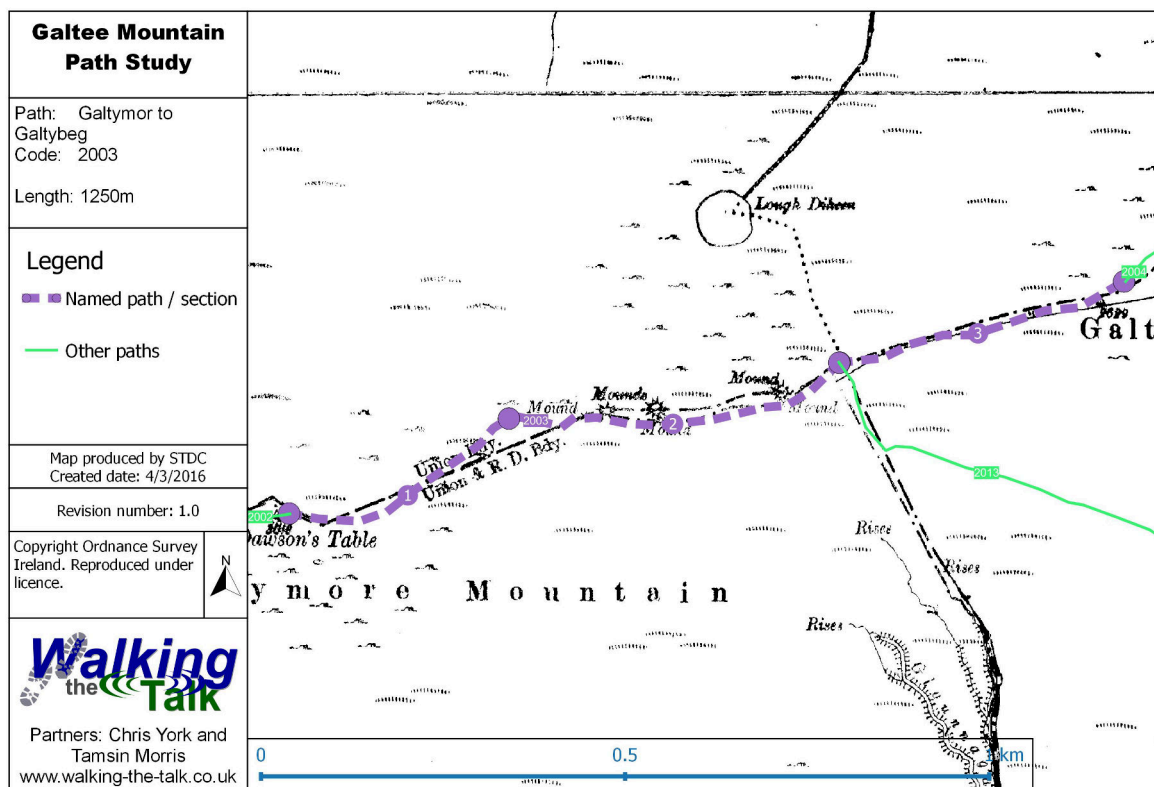
4.3 GALTYMORE TO GALTYPBEG

From the summit of Galtymore there is a well defined line eastwards but the line becomes widely dispersed with multiple braids on the slope down to the col. One well defined line traces the northern edge of the ridge and connects with a route up Galtymbeg. There are also multiple braids up Galtymbeg. There are areas of deep peat and high peat hags on both sides of the col, but also a large area where the peat has eroded down to the mineral soil.

Visitor pressure appears to be high enough to continue the expansion of trampled areas meaning that there is high potential for deterioration of the peat. However, where exposed, the mineral soil contains enough fine particles to help bind it meaning that it forms a relatively robust surface, even of slopes up to 20 degrees (>35%), and is less prone to rapid deterioration.

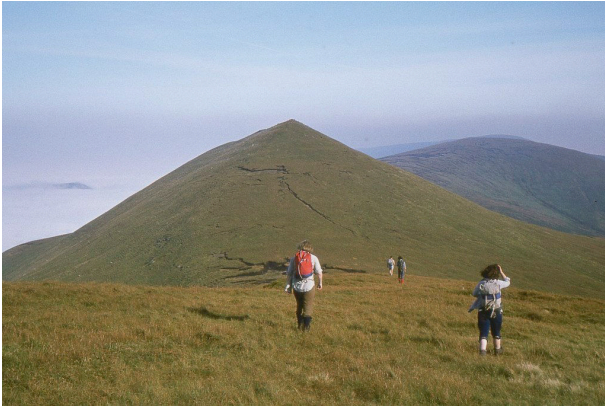
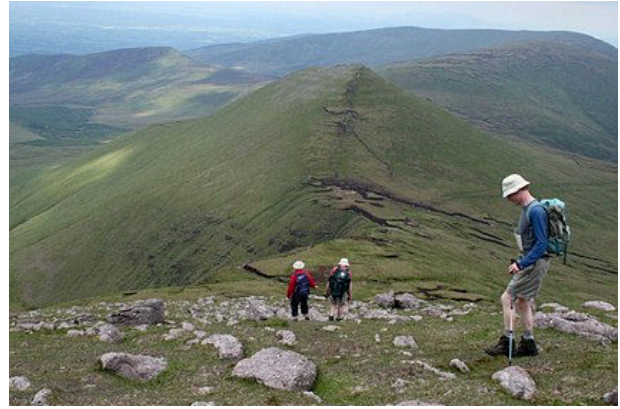
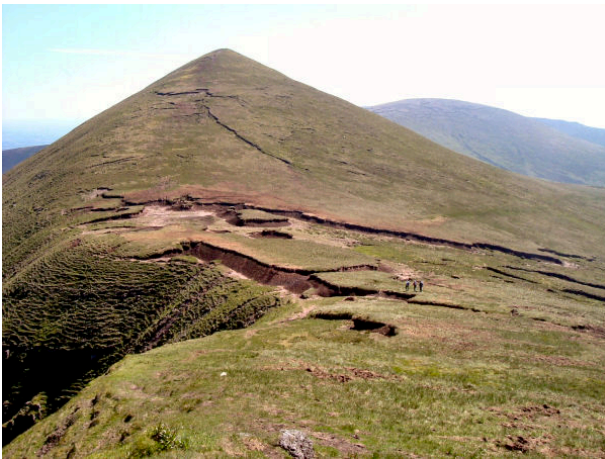
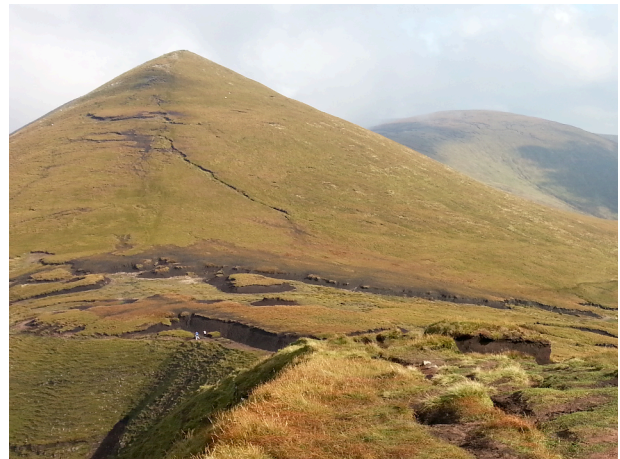
FIGURE 1: DEVELOPMENT OF RECREATIONAL DAMAGE ON GALTYPBEG

Photos available on Geograph website appear to indicate that the large exposed peat bank on the Galtybeg side of the col was not caused by recreation – it predates the development of a path. It is possible that natural, gravitational processes of the peat mass are responsible for the continued exposure of a bare peat face, but the original cause of peat degradation and erosion at the col is not immediately obvious.

Taken 1978 © Copyright Jim Barten

Taken 2008 © Copyright Kevin Higgins

Taken June 2006 De La Salle Scouts

Taken October 2015 © Copyright Chris York

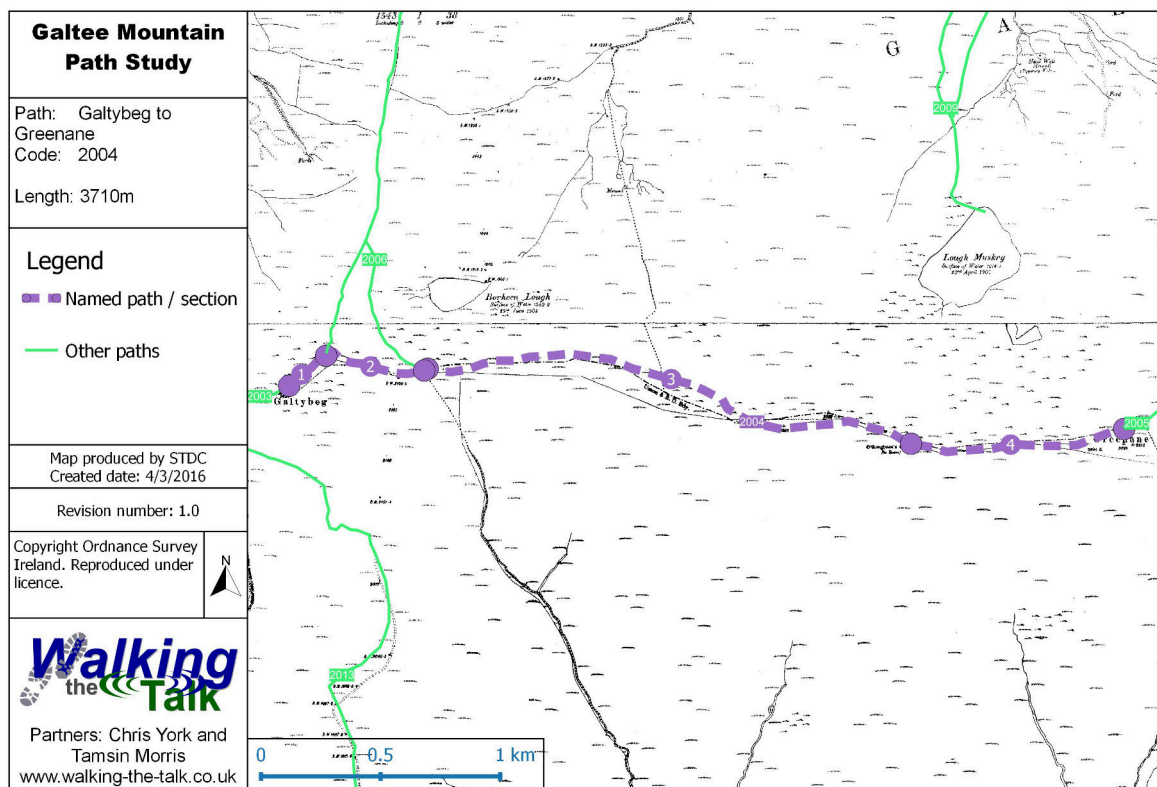
4.4 GALTYBEG TO GREENANE

There is a large flat area of exposed peat (R 897 241) which has been used by quad bikes with recent tyre tracks being visible across the bare peat along multiple routes. At the time of survey a group of four quad bikes and a scrambler bike were observed on the summit of Greenane driving across the plateau area.

Use by quad bikes, however, has caused extensive damage that is likely to deteriorate further with continued use.

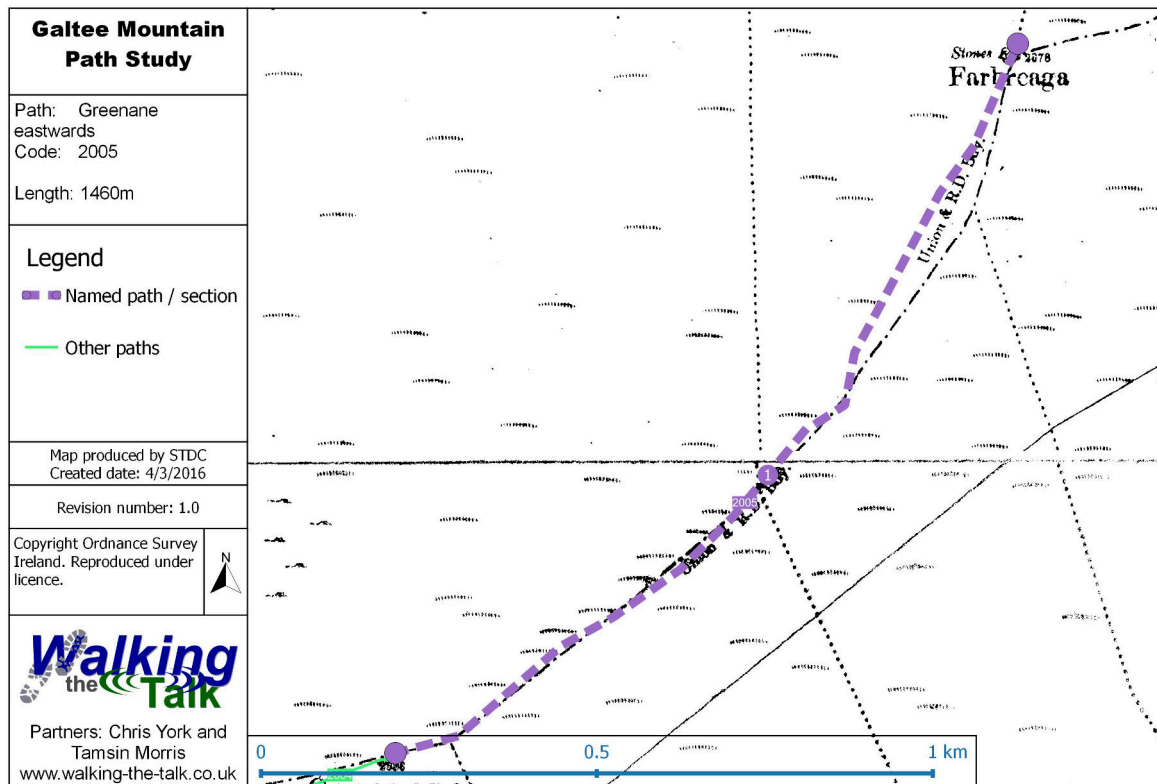
4.5 GREENANE TO FARBREAGA

The route beyond the summit of Greenane is discontinuous and crosses deep peat as well as exposed mineral soil in places; there is trampling of vegetation and patches of bare peat with footprints and multiple braids. On flat areas there is some waterlogging of the ground. However there are more obvious signs of quad bike use, with extensive damage to vegetation and large areas of bare peat with deep ruts and tyre marks.

The walker pressure on this part of the route is not high enough to cause extensive damage but further use by quad bikes will continue to have an impact on the habitats.

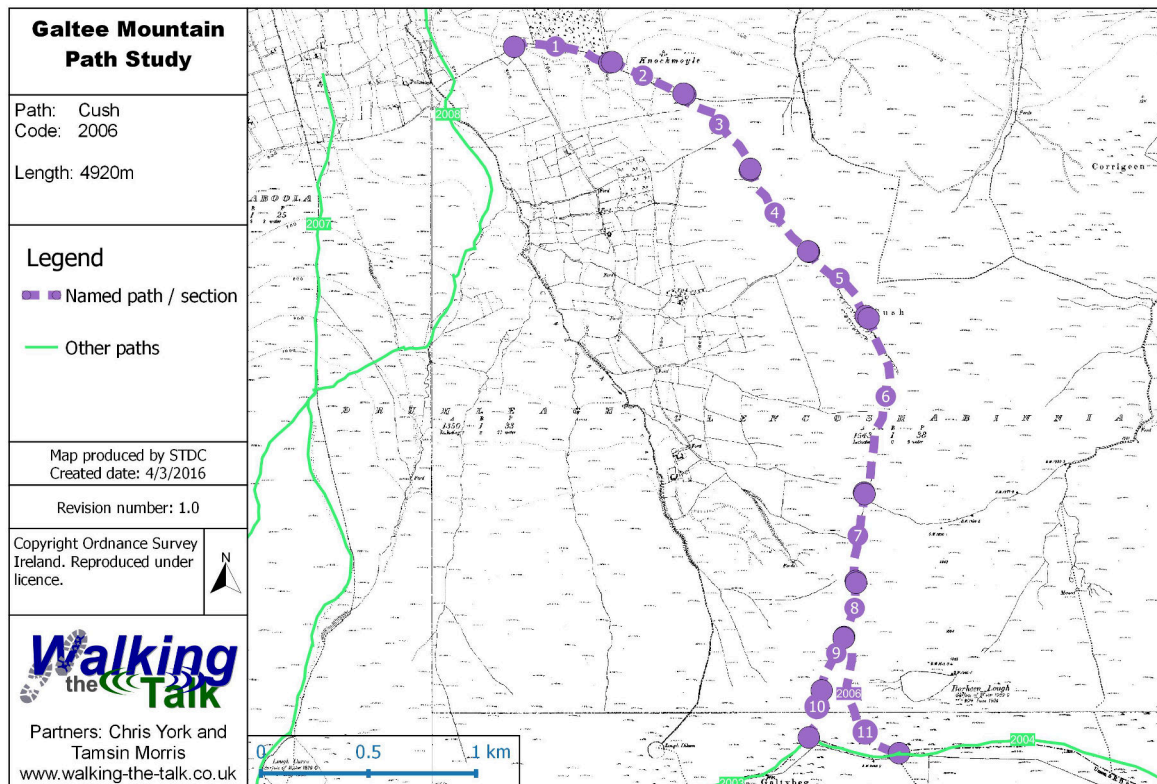
4.6 CUSH

The route was split into ten sections for the purposes of survey and the condition varies on different sections. The visitor pressure is thought to be the same for all sections apart from the choice of routes from the col between Cush and Galtybeg: this means that differences in apparent damage are most likely to arise from the sensitivity of the ground conditions.

There is an obvious line from the summit down the southern shoulder of Cush but this appears to be more resilient than on the northern slope. At the broad col pressure from walkers is dispersed over a wide area of wet ground with deep peat and the visible damage is lower intensity but spread over a wider area, particularly where people have tried to avoid wet patches.

The two sections that have the highest potential for deterioration on this route are on steep north facing slopes – up to the summit of Cush and the direct line up to Galtybeg.

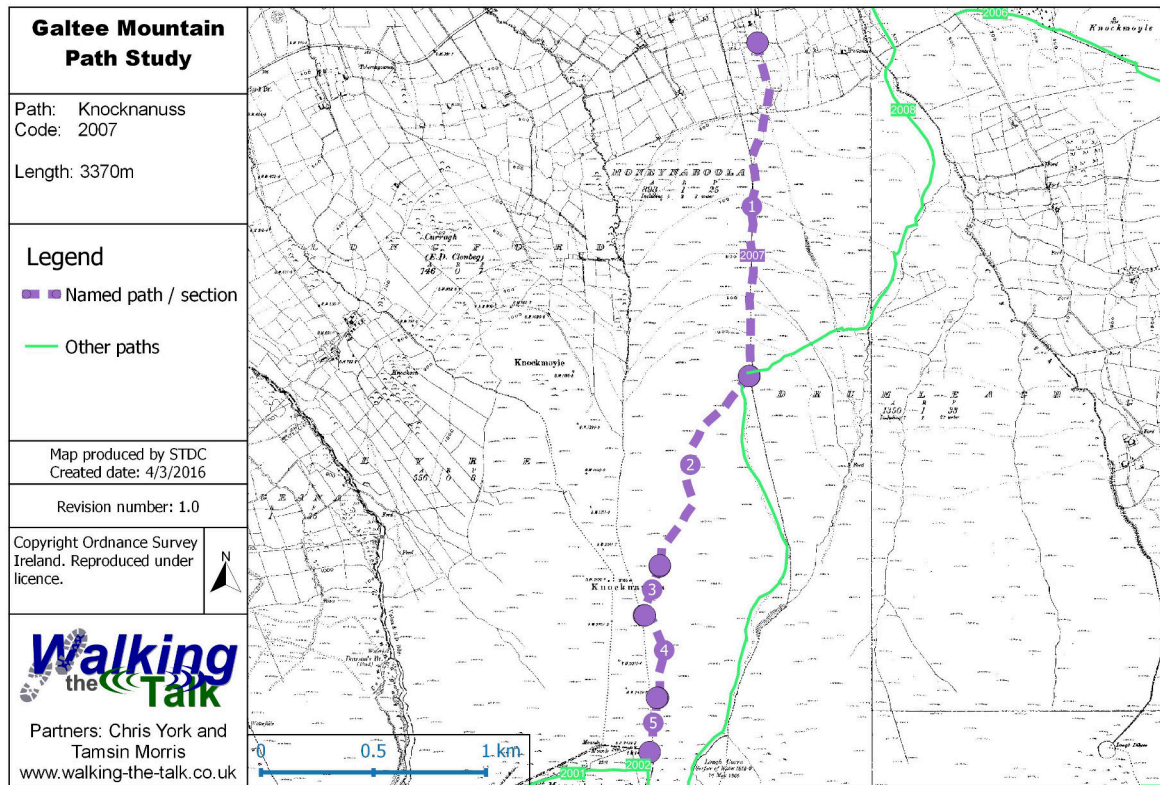
4.7 KNOCKNANUSS

Feedback from walkers suggests that this path has developed recently and has become popular in the last five years. On relatively steep ground the route is potentially vulnerable to erosion notably where surface water runs down the exposed soil.

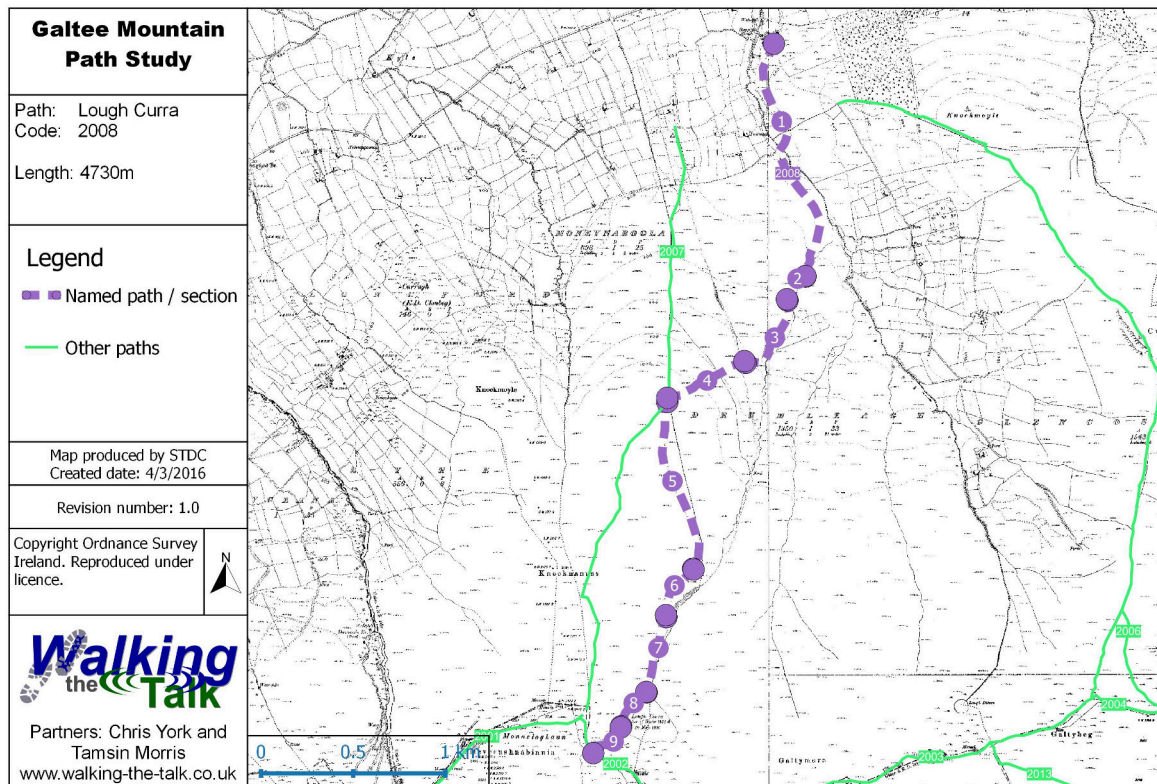
4.8 LOUGH CURRA

The route through the forest is in good condition, notably the work done by Mountain Meitheal, which has provided a sustainable surface to solve previous problems of route finding and drainage issues. These upgraded sections are appropriate to their location and appear to be well maintained.

The ice road is useable but not particularly comfortable underfoot and in places drainage failures mean that walkers are creating new braids to avoid wet ground. The way marked short cut is in relatively poor condition as it does not appear to have had any construction or maintenance – it is simply a series of posts across the hillside.

The most sensitive area is the ramp above Lough Curra – increased use would be likely to cause rapid, and potentially catastrophic, deterioration due to the steepness of the ground.

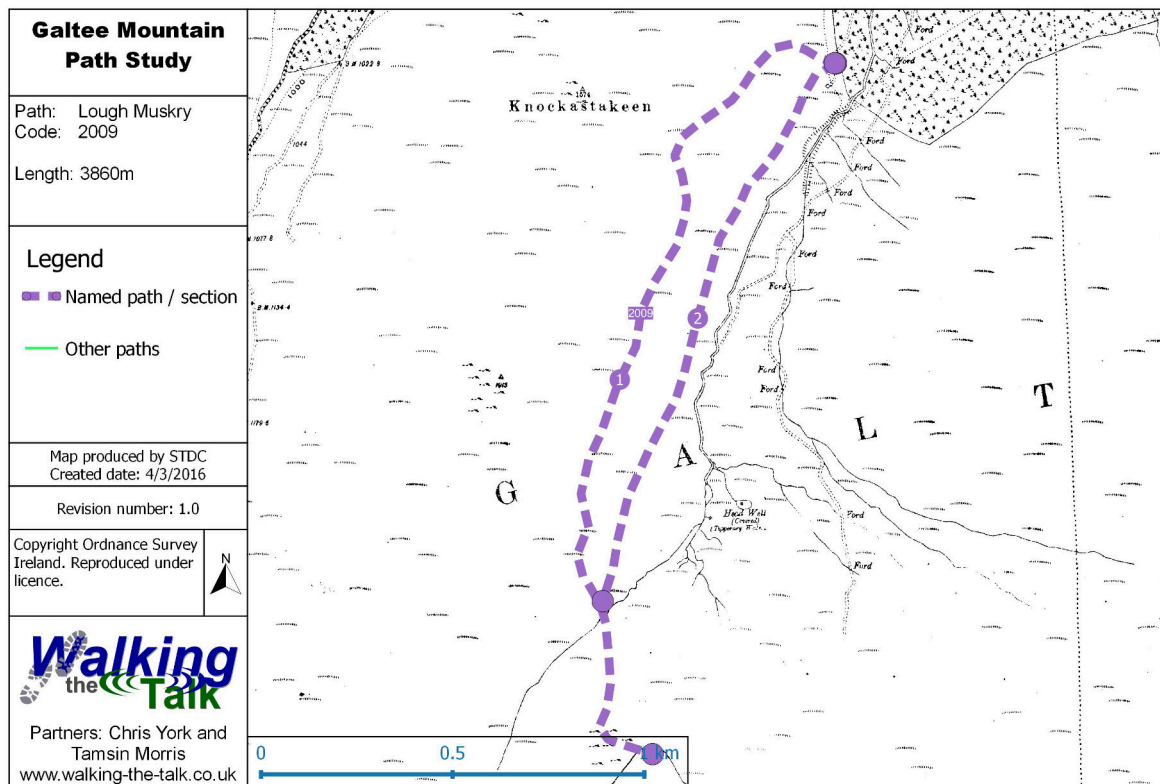
4.9 LOUGH MUSKRY

The section through the forestry is in good condition. Beyond the gate the track deteriorates, through lack of maintenance and is very rough in places. The drainage features have failed and there are signs of scouring.

Around the lough there are deep scars from quad bikes and areas of bare peat caused by repeated use.

The constructed track will continue to scour and become rougher under foot and this may cause trampling of the margins where people avoid the worst conditions.

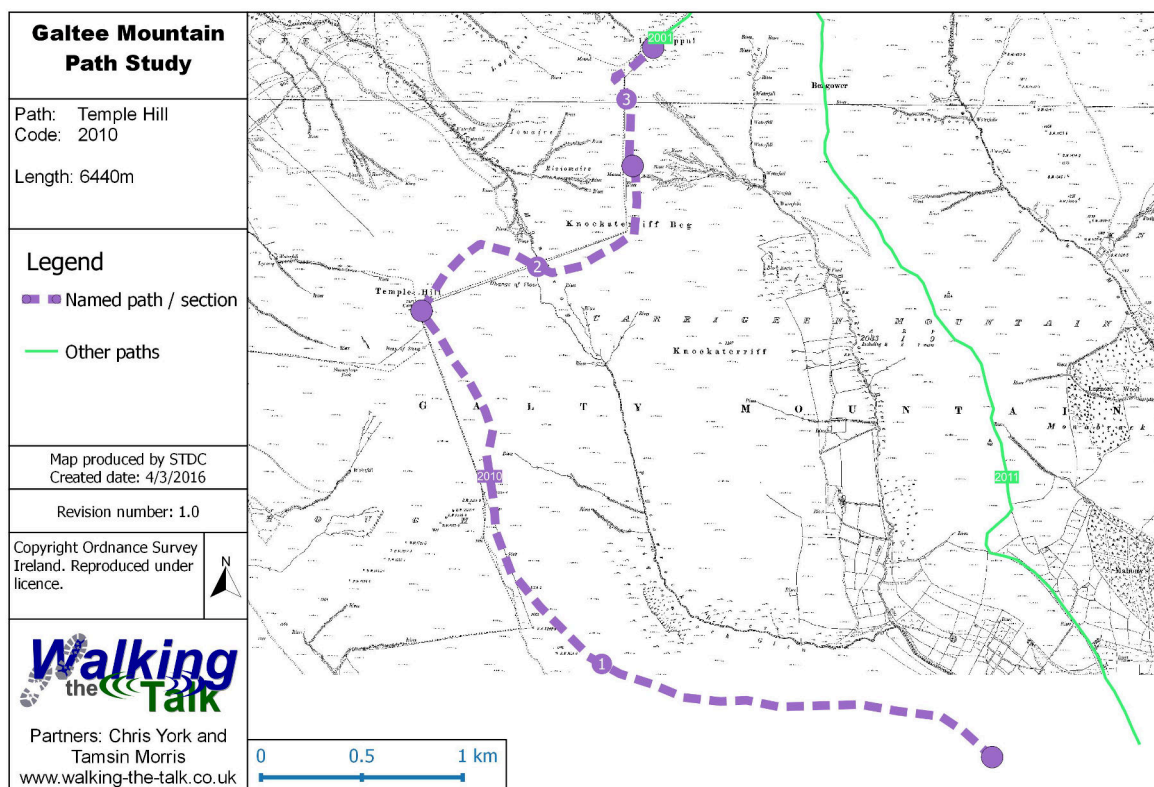
4.10 TEMPLE HILL

Current levels of use by walkers do not appear to be having a significant impact on this route. The boundary wall section, being on steeper ground and taking all of the walker pressure, may deteriorate over time.

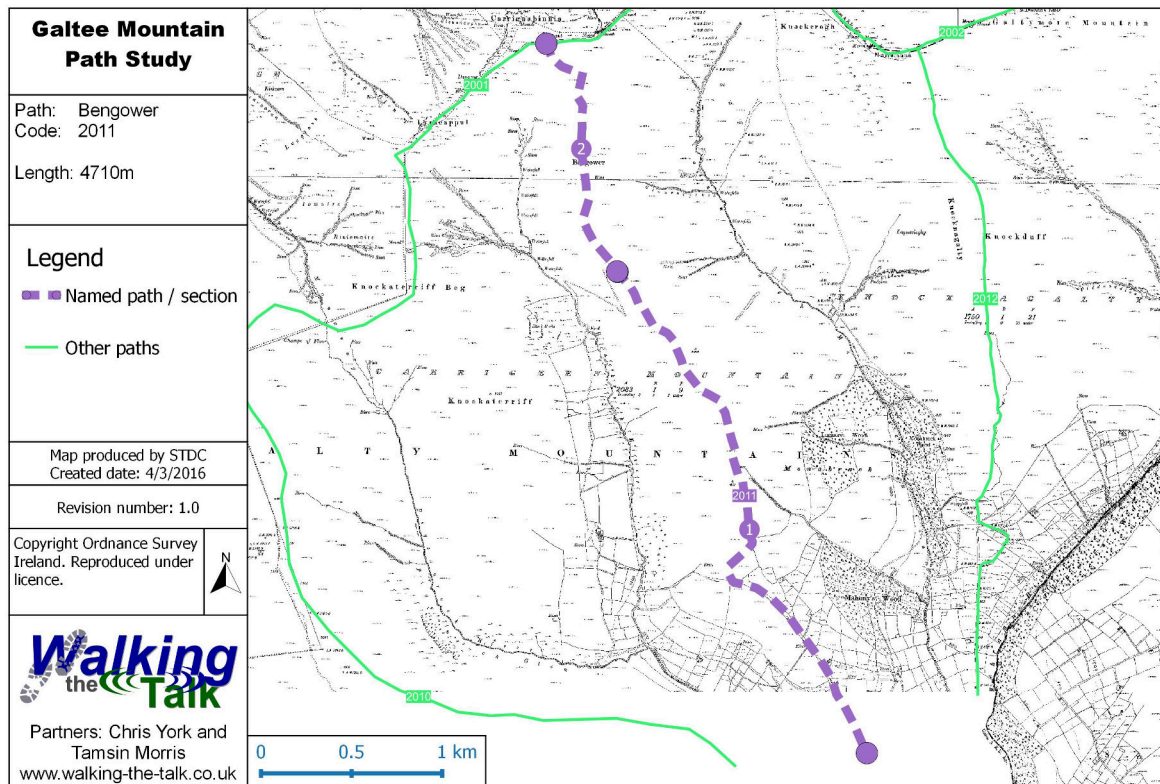
4.11 BENGOWER

There is no visible route on the ground caused by walkers although there are some tracks from quad bikes.

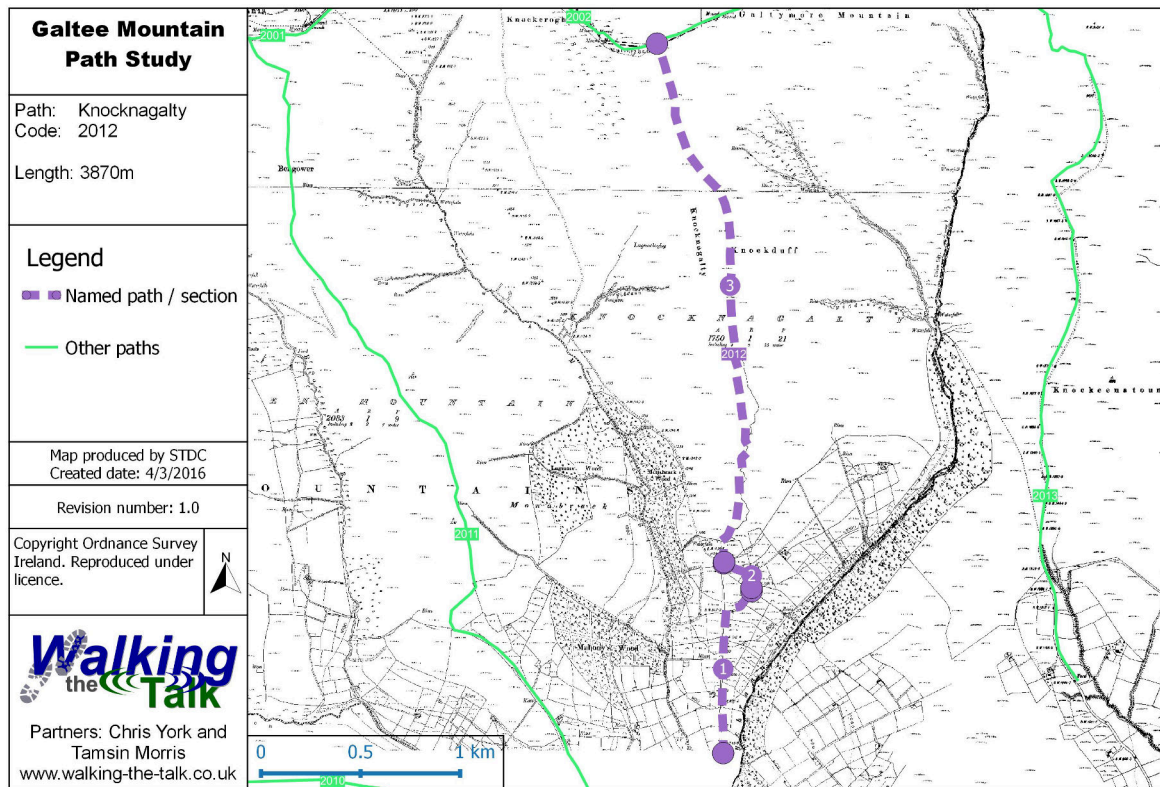
4.12 KNOCKNAGALTY

At current levels of use there is limited scope for deterioration.

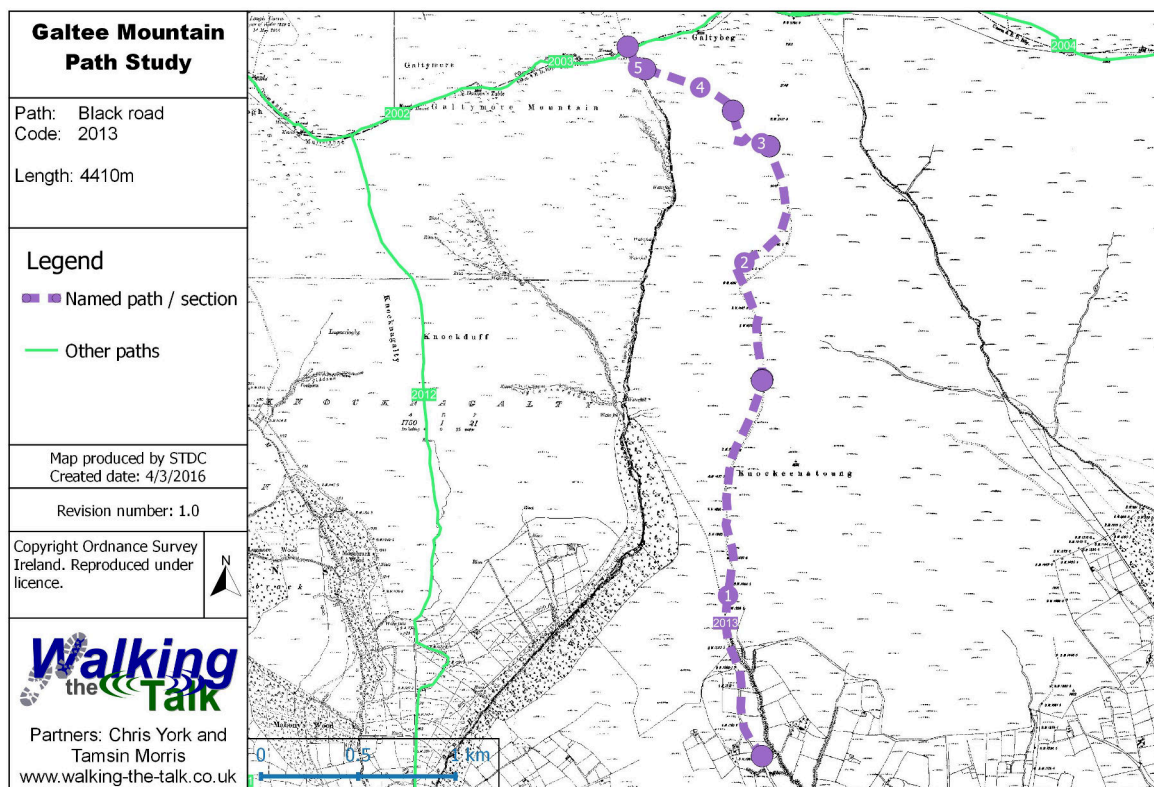
4.13 BLACK ROAD

The constructed track has been neglected for some time and many of the drainage features no longer function. This has led to erosion of the surface and some gullying – in wet conditions it appears that the track acts as a watercourse and there are many loose cobbles which make walking uncomfortable in places. Walkers are commonly walking on the track verge and there are braids on both sides for much of the way – some sections of the braids are widening as the vegetation gets trampled and conditions underfoot become wet and muddy.

Above the cairn the braids appear to be more commonly used than the track despite their poor condition. Beyond the end of the track walker pressure has caused widespread trampling of the blanket bog, with exposed peat and heavy trampling in places. The desire lines across the blanket bog appear to be self limiting – once they become impacted pressure reduces as people spread to other lines, allowing some recovery.

The constructed track could suffer from catastrophic damage during heavy storms as the drainage system is no longer functioning, however the risk of this is thought to be relatively low. The braids along the edge of the track are likely to deteriorate further but this will be limited in extent as walkers are unlikely to stray very far from the track, unless there is catastrophic damage to the track.
