Croagh Patrick Footpath Condition Report

Produced by Elfyn Jones British Mountaineering Council (Access & Conservation Officer Wales)

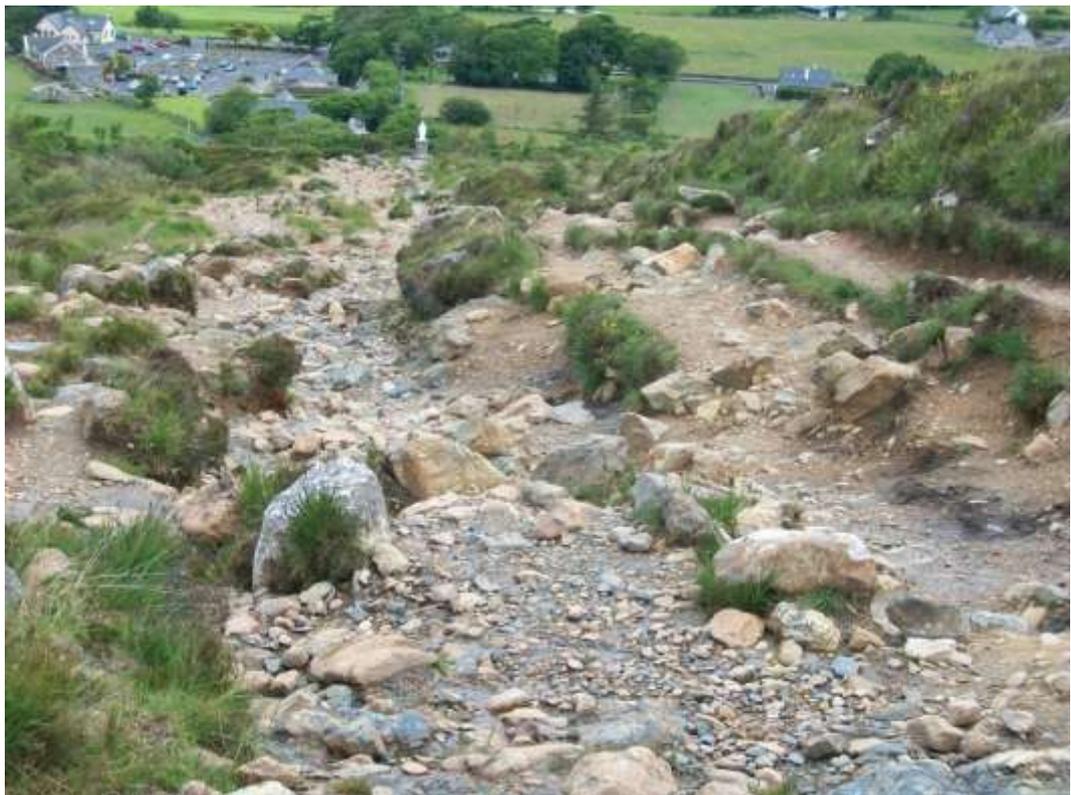
Then path departs the made up highway by a series of formally constructed steps which lead to the statue. From here the path continues beside a stream for some 500 metres to the mountain fence. The path is naturally constrained between the stream and a high bank and is at a gradual angle of approximately 15° . The soil is mainly glacial boulder clay with brown mineral soils at this point. It varies in width from about two metres up to five metres with a soil loss in places in excess of 1.5 metres. There are several braided paths with isolated “pockets” or “islands” of turf. The braiding is deeply gullied in places and appears to be worsening. There is no formal drainage and water damage and water flow along the gullied braids is very evident. The path surface is generally made up of loose and unconsolidated stones, often wet with surface water and in places very worn and uneven base rock is exposed making for a very uncomfortable walking surface which walkers try to avoid, exacerbating the problem.

Section 1 – Looking northwards down the path to the start – braiding and turf “islands” very apparent, as is lack of any drainage. During heavy rain this would resemble a stream.

This section lends itself well to traditional stone pitching technique – the path would need to be narrowed and a stone pitched path, contained by the natural topography of this section would be a durable and sustainable solution to the problem of erosion. A large number of water bars and open stone pitched drains would need to be constructed to take water off the path to the nearby stream. The path width could be narrowed to a maximum average width of 1.5 metres but care would need to be taken to ensure that that path would not be too formal or of uniform width. The exact line of the path would need to be a flowing, slightly curving line, avoiding a straight line. The eroded areas would need to be recovered by using and transplanting turfs and vegetation from adjacent stable slopes, being careful not to create erosion at those points. The main logistical issue would be that of availability of stone – a stone pitched path of this magnitude would require approximately a half of ton of suitable stone (both in colour, texture and geological type) per metre. As suitable stone is not found on site this would require it to be airlifted in by helicopter, and a minimum of 300 separate 500kg bags of stone would be required. This would be roughly seven full days of helicopter time, costing possibly as much as €10,000 for the helicopter time alone. A team of four skilled people with machinery (including mini-diggers and mechanical tracked wheelbarrows) would require at least six months to complete this work. The labour costs for this would be in excess of €75,000. So in total a contingency of over €100,000 would be required to complete this section alone.

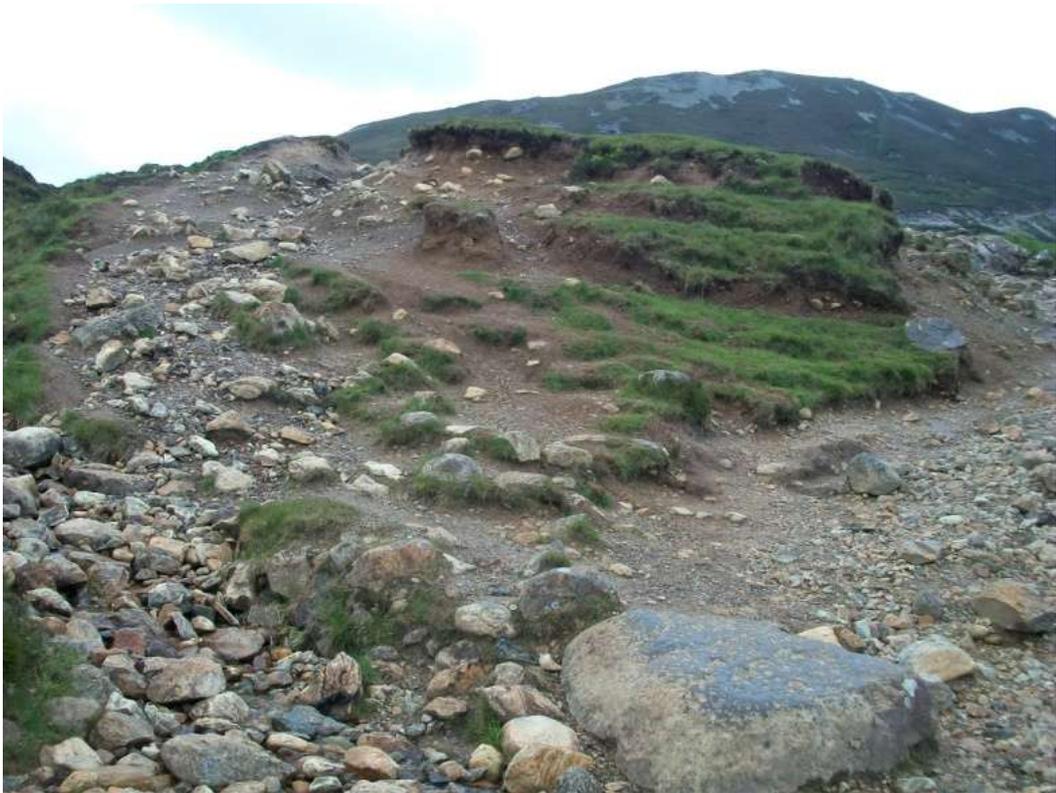
This section of path lies close to the stream and is some 500 metres in length. Although in general the erosion here is not as severe as the initial section, the path has several different lines, all cut deeply into the mineral soil. There are several different path lines in a fairly narrow (less than 10 metres wide) corridor. As the path ascends the mountain to a more level section the erosion worsens considerably and just before the point where the path reaches a level section the path splits and a large erosion scar has been formed, which could imminently and catastrophically worsen if the “island” of remaining turf and vegetation were to erode further.

The large “turf island” halfway along Section 2 before the path levels out.

Parts of this section (the steeper sections) also lend themselves to stone pitching, but in addition a number of paths need blocking off and shallow retaining walls built on the top side of the path. These retaining walls would consolidate the path sides and prevent loose materials being washed on to the path surface. As with the previous section a full survey and specification would be required to identify where cross path drains and water bars were required. Again this section would require additional stone to be imported, but probably only about 150 500kg bags of stone. Again some €75,000 of labour would be required.

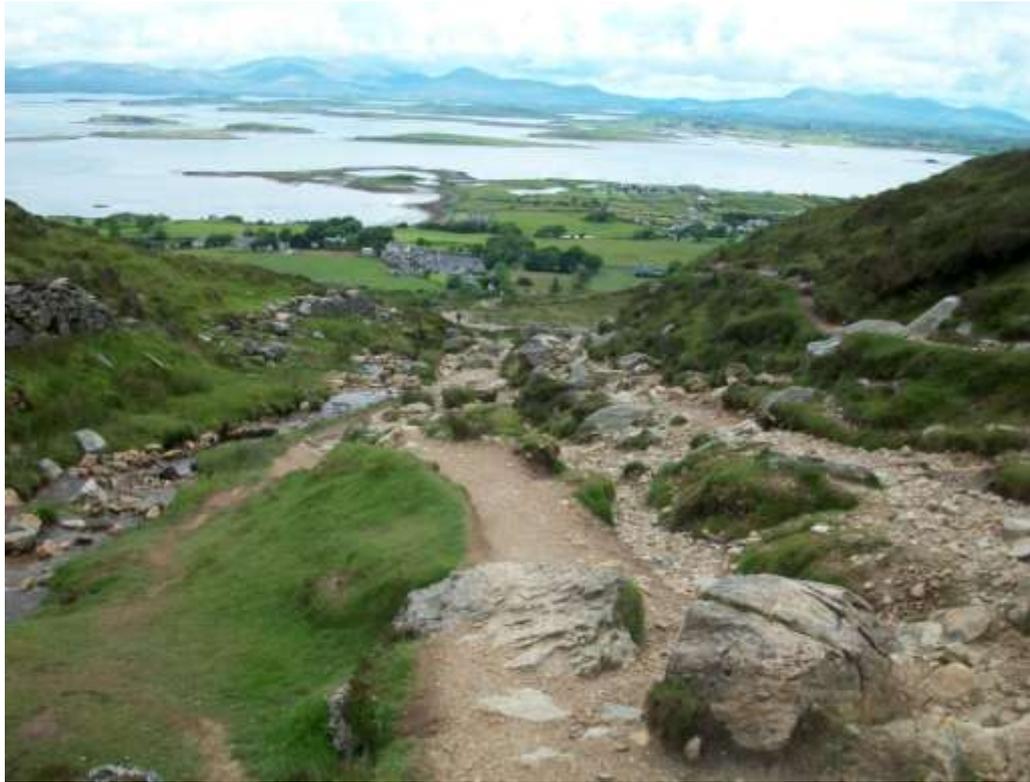
Looking northwards down the lower section of Section 2 – this is just below the turf island shown above

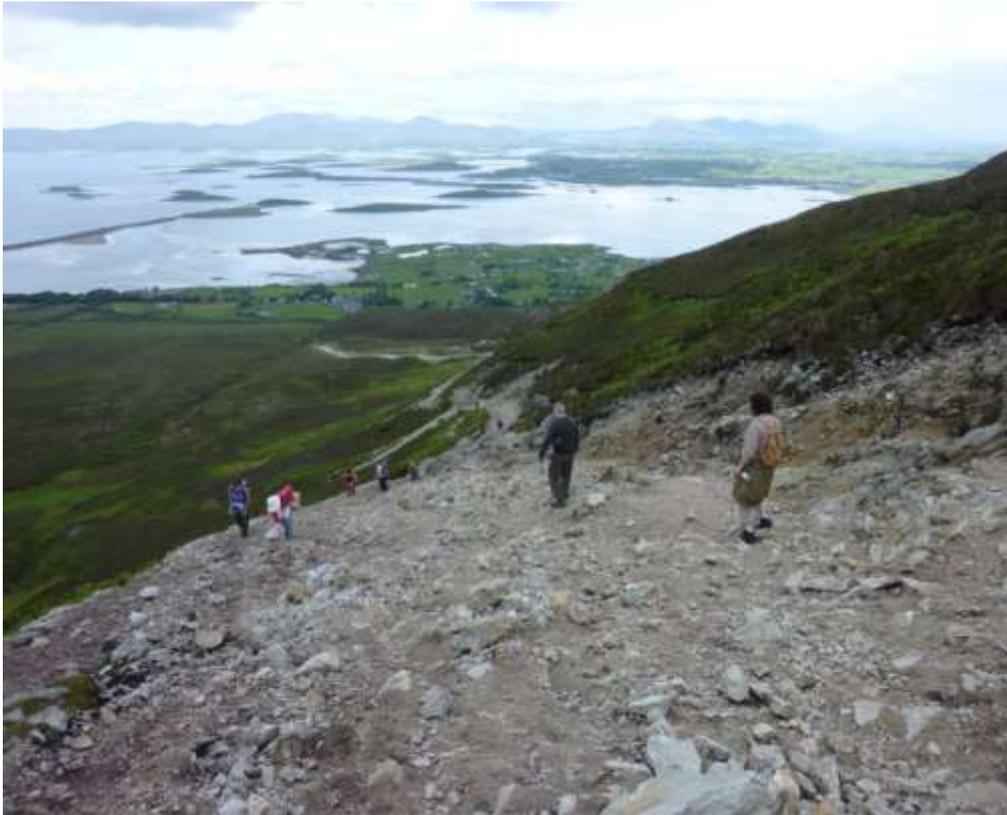
The path steepens appreciably as it rises up the side of the wide ridge. The path follows a steepening line, “cut” in to the side of the hill, in a gentle curve overlooking a shallow north facing valley. The angle here is approaching 30° and the upper eroded edge of the path is in excess of 3 metres high in places. This upper retaining edge of the path is severely undercut and is providing a constant source of loose and unconsolidated material which then gets washed out of the path, and onto the grass and heather slopes below the path – creating a visual eyesore but also covering the vegetation and inhibiting growth creating further erosion. The problem is particularly acute just over halfway up the slope, as the path ascends past a slight rocky section. The path here is in excess of 25 metres wide, with as much as 3 metres of (continually eroding) retaining bank on the top side.

Looking north down the upper part of Section 3 – in the middle distance, the upper part (the least eroded section) of Section 2 is clearly visible.

This is a very difficult section to work on due to the steepness and scale of the problem. It's highly impractical to consider stone pitching the whole path surface to the col – the scale is just too immense and the amount of stone that would be required to be airlifted is of a magnitude and cost that cannot be justified. Pitching this section would also change the character and nature of the path and the challenge that is Croagh Patrick. However the ever-eroding upper retaining wall is providing a constant source of loose unconsolidated material on the path – consolidating this retaining wall and providing a number of cross path drainage channels and water bars is the priority here. Again stone would need to be airlifted in and very shallow retaining walls constructed on the top side of the path, the walls constructed using turf as “mortar” which in time would grow to obscure the walls and provide more stability. Again there is at least six months of work for a team of four skilled persons here plus the need for some 200 500kg bags of stone.

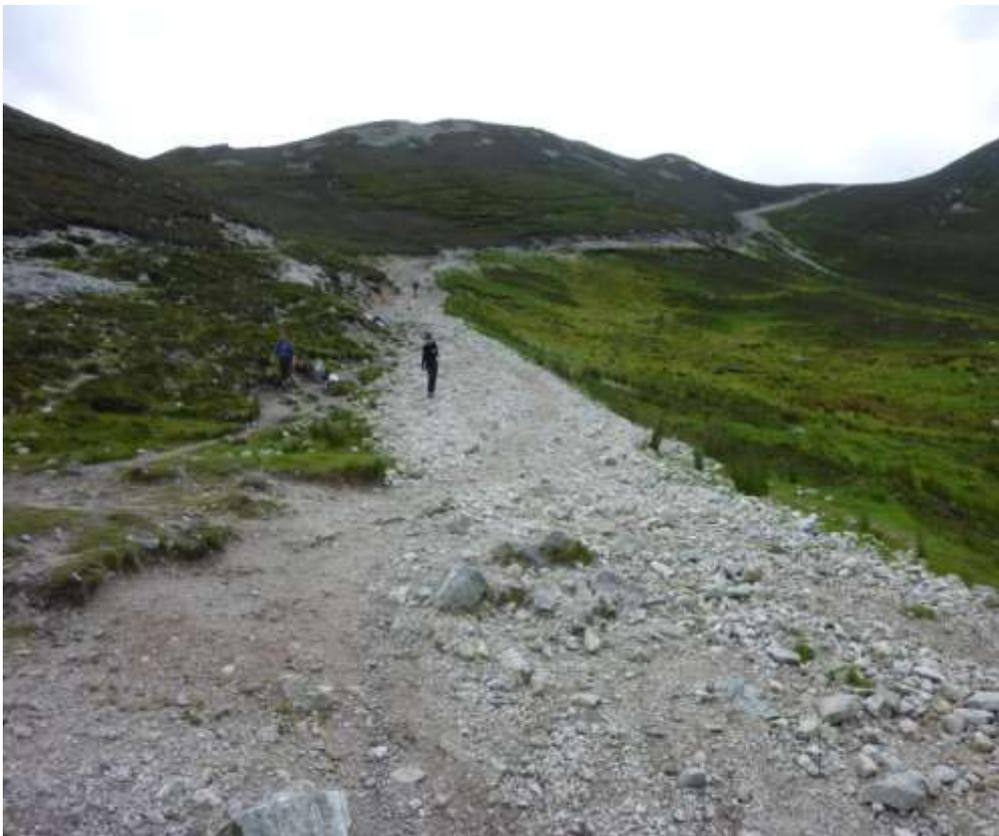
Section 3 Looking southwards up the mountain towards the col – a distance of approx 500 metres.

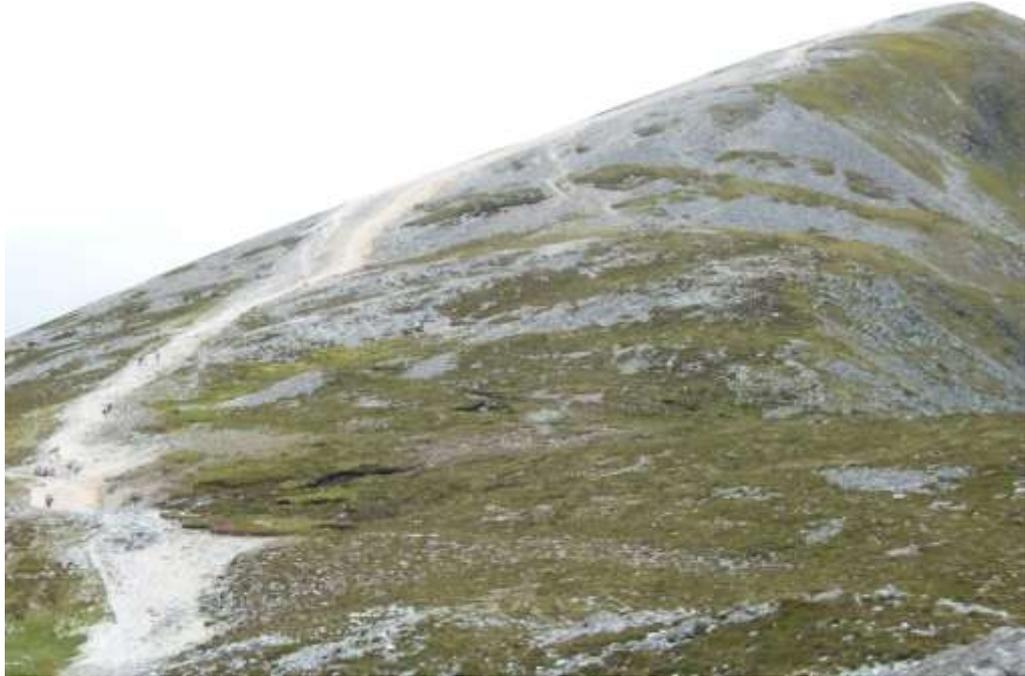
The summit cone is a geomorphological feature of some significance – being composed on the east side of a steep block scree slope – which in its natural state would provide an important and significant habitat of stable scree and “montane” habitat. However the path along the south-east ridge ascends initially up an eroded scar before a slight turn northwards up the final steepening leads to the summit dome. The path is obviously highly mobile – both underfoot and in the medium term it also appears to be slowly eroding and migrating in a northwards direction, cutting into the scree slope creating an unstable bench (or cutting) on its north side, leading to more unconsolidated material on the path surface. The upper loose and eroding retaining wall of the path here is in excess of 2 metres high, and unless this “retaining” wall is consolidated the path line will continue to migrate northwards creating more erosion and loose material and irrevocably damaging what is arguably the most important nature conservation feature of the mountain. This is also the location for most mountain accidents – it’s the steepest and loosest section and is particularly treacherous for ill-equipped and inexperienced walkers in descent.

Section 5 The “summit cone” with the line of the path following a steep scree slope – the width of path here is in excess of 30 metres and is clearly and actively “migrating” into the ecologically sensitive and important scree slope to the north (right) of the path.

This is the most isolated section – and the logistics and practicalities of working at this exposed and remote section have to be taken into account when considering options here. As with the previous section to the col, the option of stone pitching the whole section is technically possible but impracticable both from a logistical perspective and from an aesthetic and challenge perspective. The challenge here is to prevent the slow but steady and marked migration of the path by providing a stable and durable retaining wall to the north side of the path. It's possible that sufficient stone exists for this to be constructed without resorting to importing stone here. As with the other sections, the exact locations for stone drains need to be identified by several visits during times of heavy rainfall. A critical factor in the construction of the retaining wall is ensuring that the retaining wall does not get undercut by erosion from water and walkers - and it's possible that some sort of simple pitching may be required along the base of the retaining wall. Ideally more formal pitching would be required at the so-called “bad step” to stabilise the path surface and prevent the ever-eroding path from cutting further into the scree slope. Due to the complexities of working at this level

and the steep nature of the terrain there is at least 12 months of work on this section alone for a team of four people.

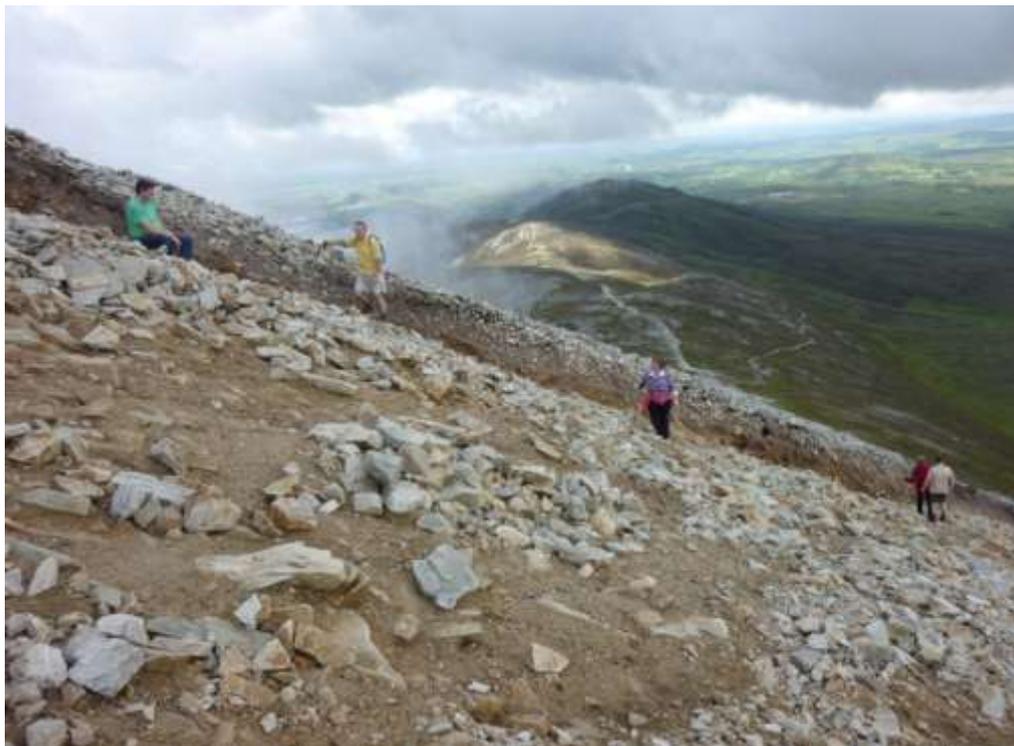
Close up of the actively eroding “edge” of the path up the summit cone – the rate of erosion here appears significant but could be determined by monitoring.

- It's strongly recommended that a programme of series of fixed point transects and photo-monitoring is established at key points along the path. This would measure vegetation cover, width/depth of the path, soil loss and path surface material. This should ideally be GPS linked and should be able to be easily repeated in future years. This work could also demonstrate the effectiveness or otherwise of the success of any path works and identify the areas of greater priority. It could be argued that any available funding should concentrate not on those areas that are currently regarded as being the most visually eroded, but on those sections where the rate of erosion and the visual impact is greatest.
