### Section 3 - Scree and boulder mid section - BC figure 1.

# Devil's Ladder Feasibility Study

## **Section 4 - The Upper 30 Metres:**

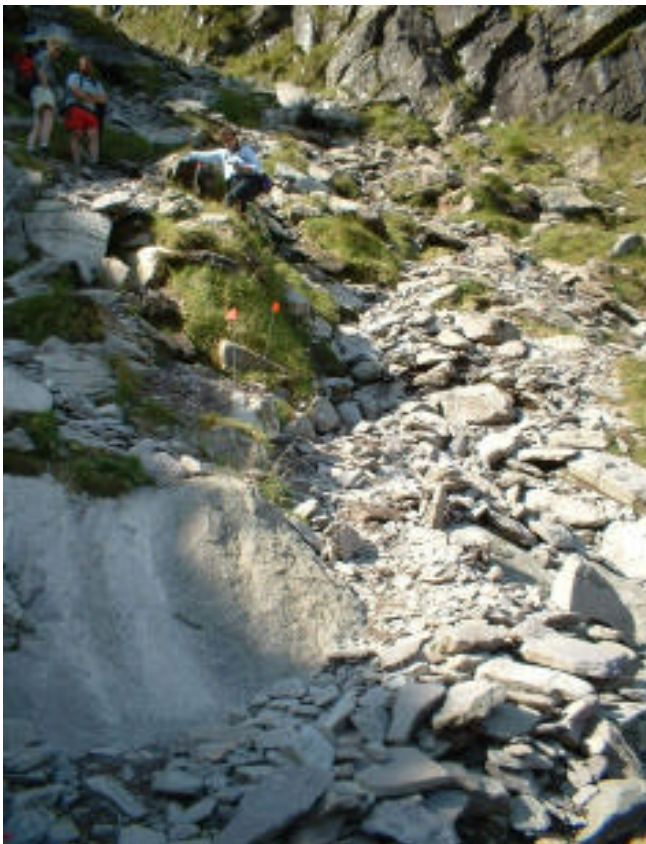
This section of the route is characterised by loose scree and boulders. (See Figure 4). This makes the route particularly unstable and the average user may experience difficulty in choosing a safe route, especially when tired and descending. The route gets considerably steeper approximately 2/3 of the way up.<sup>1</sup> Route finding becomes increasingly difficult. There are a few places in this area that require the walker to use their hands as well to ascend or descend the path. Route definition in this area with scree walls<sup>2</sup> would aid the average user and improve the safety of the route considerably. The area also requires “soil” stabilisation and water management.

**Figure 1. Typical conditions on Section 3 with loose scree and boulders.**

With the amount of scree available on site, the trail definition could be accomplished by the strategic construction of trail cairns 2-3 feet high along the chosen route. Scree walls are also recommended as an additional method to define the path where necessary.

The route should follow a zig zag route of ascent, this will increase the stability of the route and limit soil and rock movement.

Along with path definition we recommend that a series of trail stabilizers be installed. On site materials could be used to construct such features as

- **stone stairs/steps** - to stabilize the tread way,
- **crib walls** - to stabilize the tread way linearly and prevent the tread way from creeping downhill and
- **scree walls** - to keep users on the intended path.

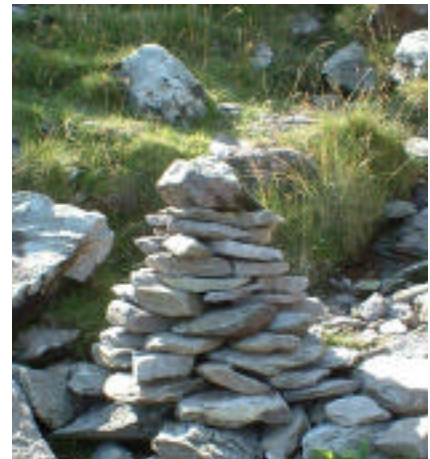
**Figure 2**  
**Constructed cairn a possibility for defining the route.**

**Cairns** are considered here as the most suitable as they are a “historical artefact” along this route already. Furthermore they are sustainable and can be easily removed in future if required and are built from natural material.

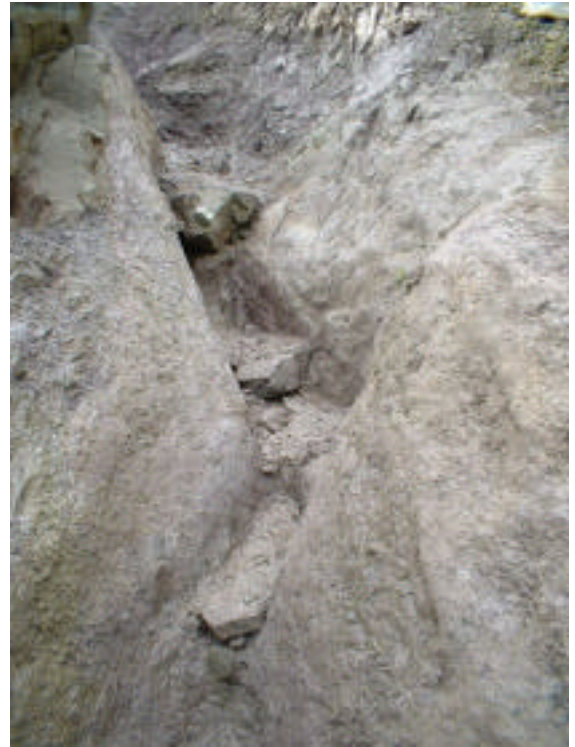
**Figure 3**

The most serious case of route and natural resource degradation in the form of soil erosion occurs in the top 30 metre section of path below where it intersects with the saddle between Corran Tuathail and Cnoc na Toinne.

The clinometer reading measured the gradient on this section at 37 percent.

In this section, we measured soil loss in places of up to 2 metres deep and 2 metres wide. The uppermost section before the saddle the path is braided into 3 major sections. Rock boulders have and continue to become more exposed with the increase in erosion and some hang precipitously suspended in the surrounding soils. With increased erosion these and more rocks will inevitably be dislodged.

There is a real possibility that hikers will unintentionally knock some of these rocks loose as they grab onto them for handholds. The grade is such that there is

**Severe erosion occurring at the top of the Devils Ladder.**

- **Relocation.**  
The team recommend that this upper 30 metre section of trail **be relocated**. This is necessary to keep users from adding to the soil erosion in this section while rehabilitation efforts are taking place.  
The relocation of the upper section onto the grassy slope on the right side of the path (ascending) is expected to be temporary as it is doubted that this section can sustain heavy continued use over the many years without eroding.
- **Bench cut path**  
The relocated path should be constructed as a bench cut construction and have a gradient of no more than 10 to 12 degrees.
- **Ladder rungs** should be constructed at the approach to the gully to give access to the relocated path (See point X figure 7 )

The upper 30 metres of path require a series of rock check dams installed to stabilize the existing path. The area should be rubbled to prevent further erosion from occurring.

The upper reaches of the path should have geofabric installed as well to encourage and accelerate re vegetation in this area.

Signs should be installed to educate users to stay of this area as re vegetation requires their cooperation. A sign should also be installed to direct walkers to the relocation. To keep users from straying onto the re vegetation/closed area, a type of temporary fencing should be considered.

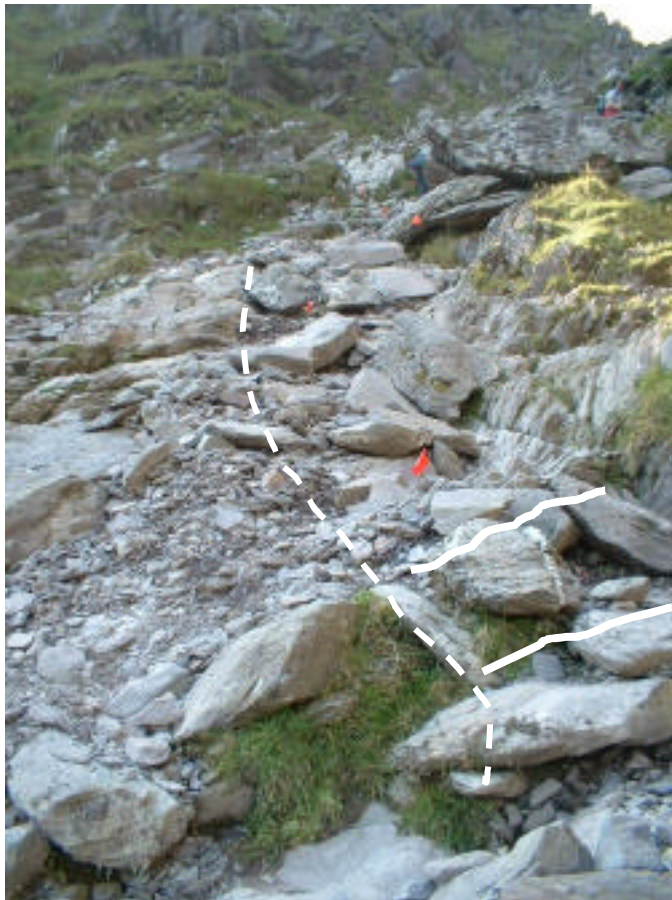
**Figure 9**  
A rock crib constructed along the dashed line will limit soil and scree movement. Stone steps could be constructed where solid lines are marked.

**This route rises at a more suitable gradient.  
(note the marking flags.)**
