Progress at Croagh Patrick

Work underway to address path erosion

Written by
Helen Lawless,
Access &
Conservation
Officer

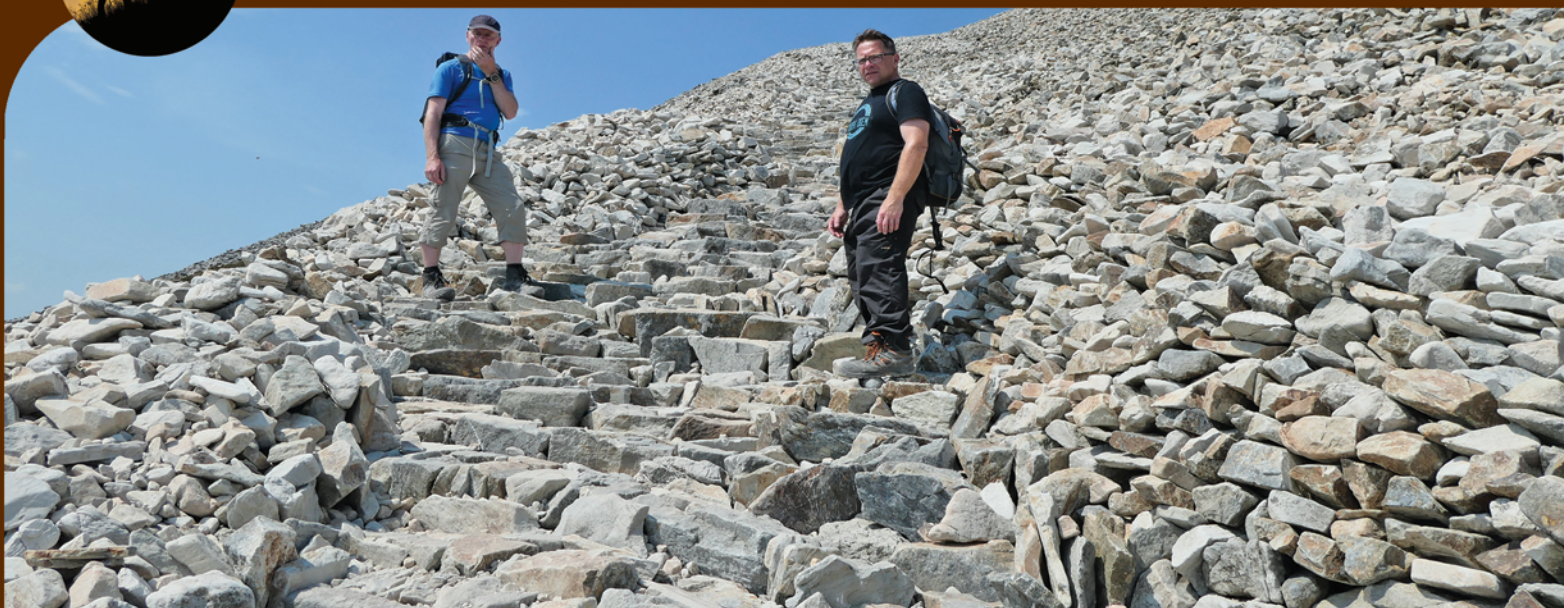
Martin Keating, Chairperson of Croagh Patrick Stakeholders Group, with the Path Manager, Matt McConway, looking at the path on the cone at Croagh Patrick. The path is made by clearing loose stones from a two-metre-wide line, gathering stones from the mountain to create the path, and carefully positioning every stone so that it is solid and so that it works with its neighbouring stones to provide a stable footing. The path is made up of shallow and higher steps, designed to suit people of different abilities and to blend into the landscape. The path is strengthened by revetments on either side.

The path work on the cone is a complex process, using a bespoke stone-pitching technique, with all the work being done by hand. The skill and effort required to complete every single metre is phenomenal. The path offers a stable footing and blends into the landscape, providing a solution that protects the mountain from continuing erosion, without the intrusion of an obviously constructed path.

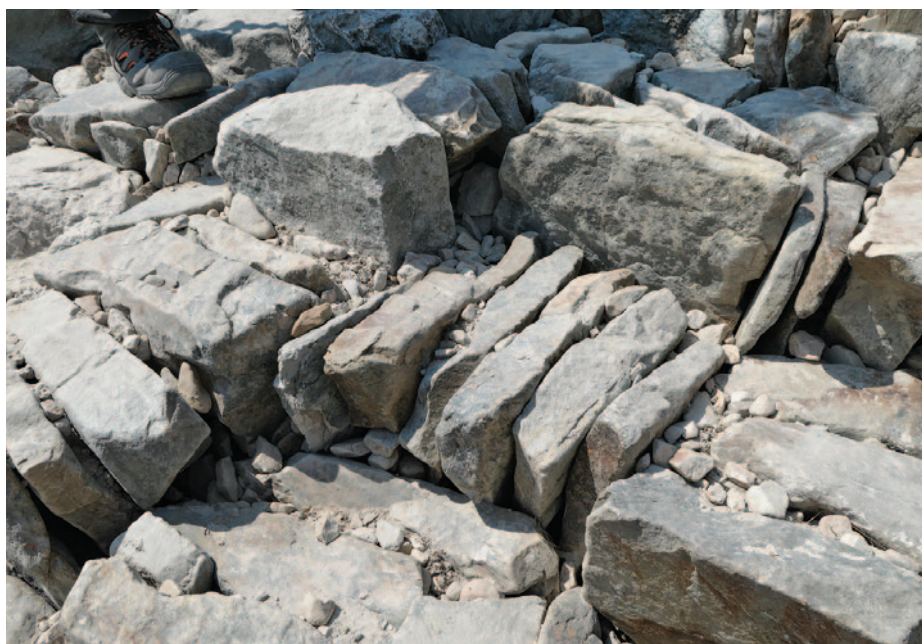
Close-up image showing the structure of the path on the cone at Croagh Patrick
